## Interference

## MXL2, MXG and MXS power noise related to the “crank”

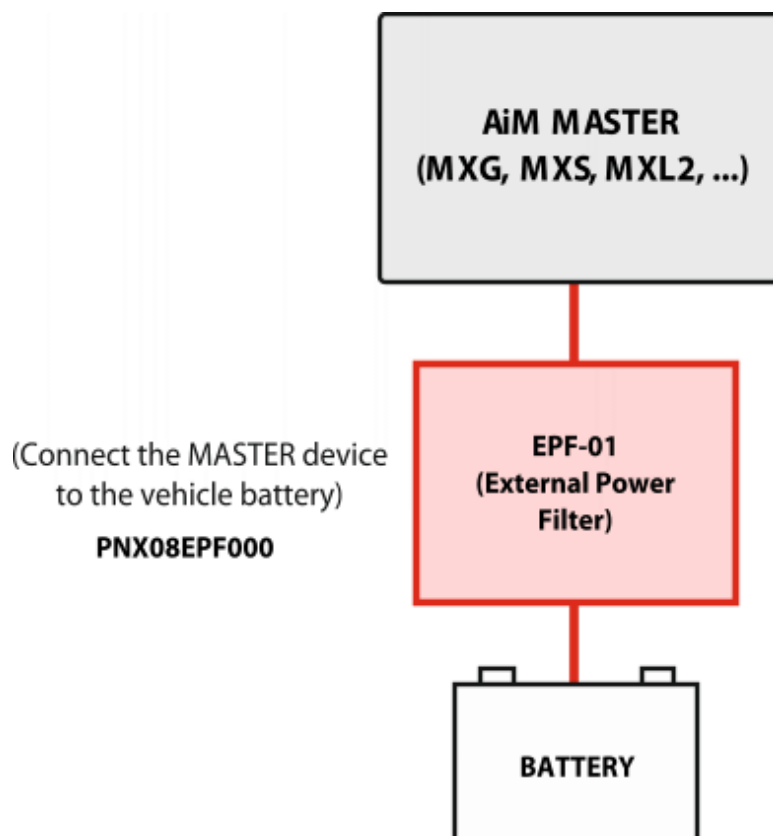
Dash locks at the “crank”.

Use the external power **filter** EOF-01 part number: **X08EPF000**
